Exhibit 3

DECLARATION OF CHIYE AZUMA

*Declaration of Chiye Azuma
Chimes Creek Notice of Citizen Suit*

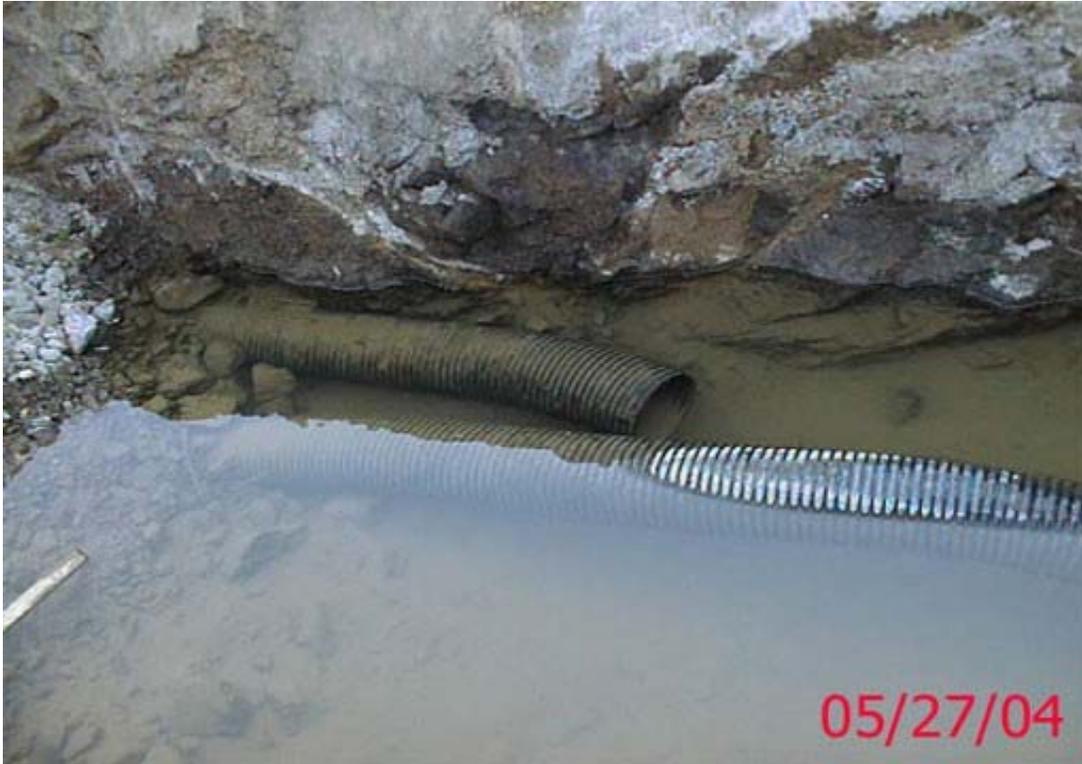
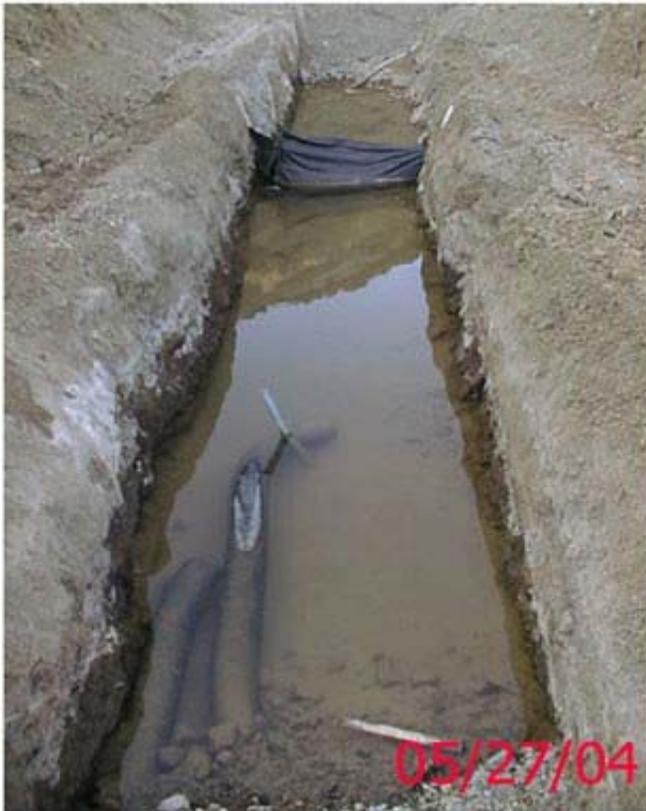
Exhibit 3.1

Photographs by Mark Brest van Kempen on May 27, 2004 of black drain pipes at the bottom of a muddy trench of the former holding pond.

16. DeSilva and city staff repeatedly denied this dewatering activity was taking place. The denials continued until we circulated these photos showing drainpipes pumping out muddy groundwater directly into the storm water manhole, and contacted the RWQCB for additional oversight. Email to Keith Lichten, Senior Engineer, San Francisco Bay RWQCB (May 28, 2004). In support of my request for additional RWQCB oversight, I attached a record of the violations of which I was aware. *See id.*

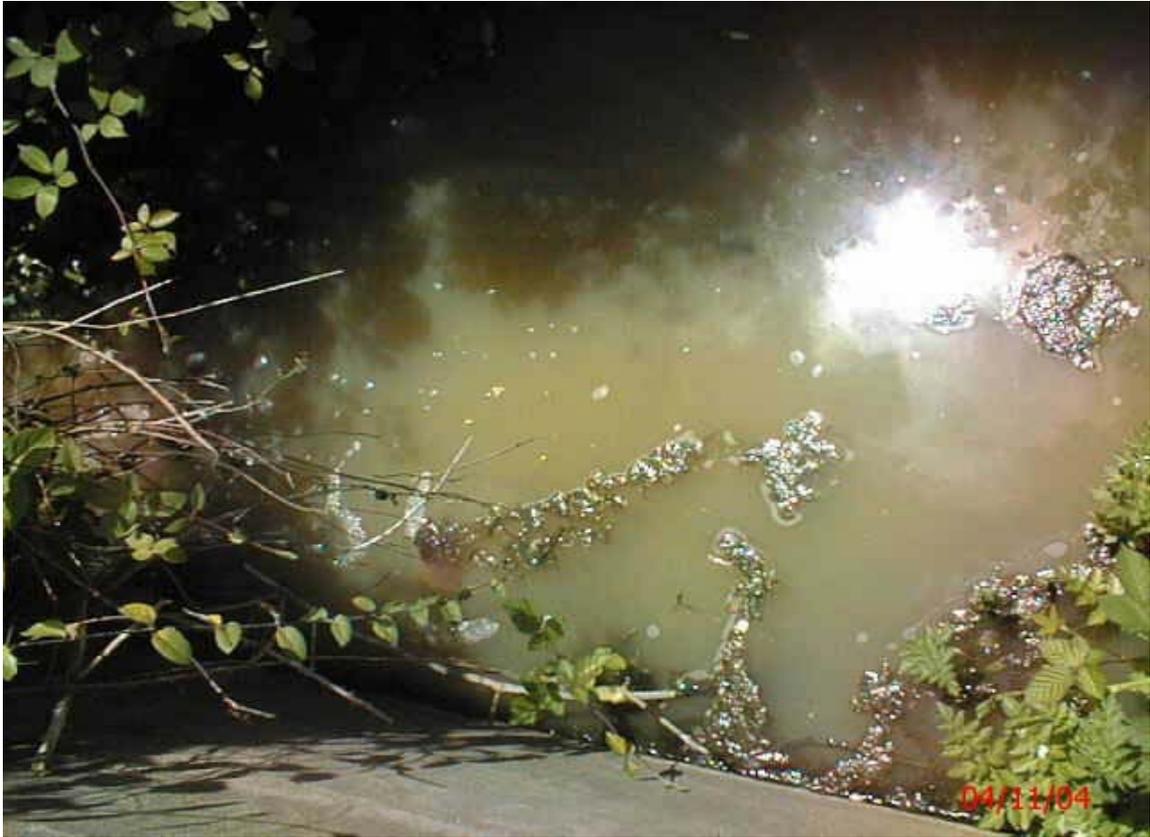
Exhibit 3.2

Photograph by Mark Brest van Kempen on April 11, 2004 of Chimes Creek behind 3835 Delmont Ave.

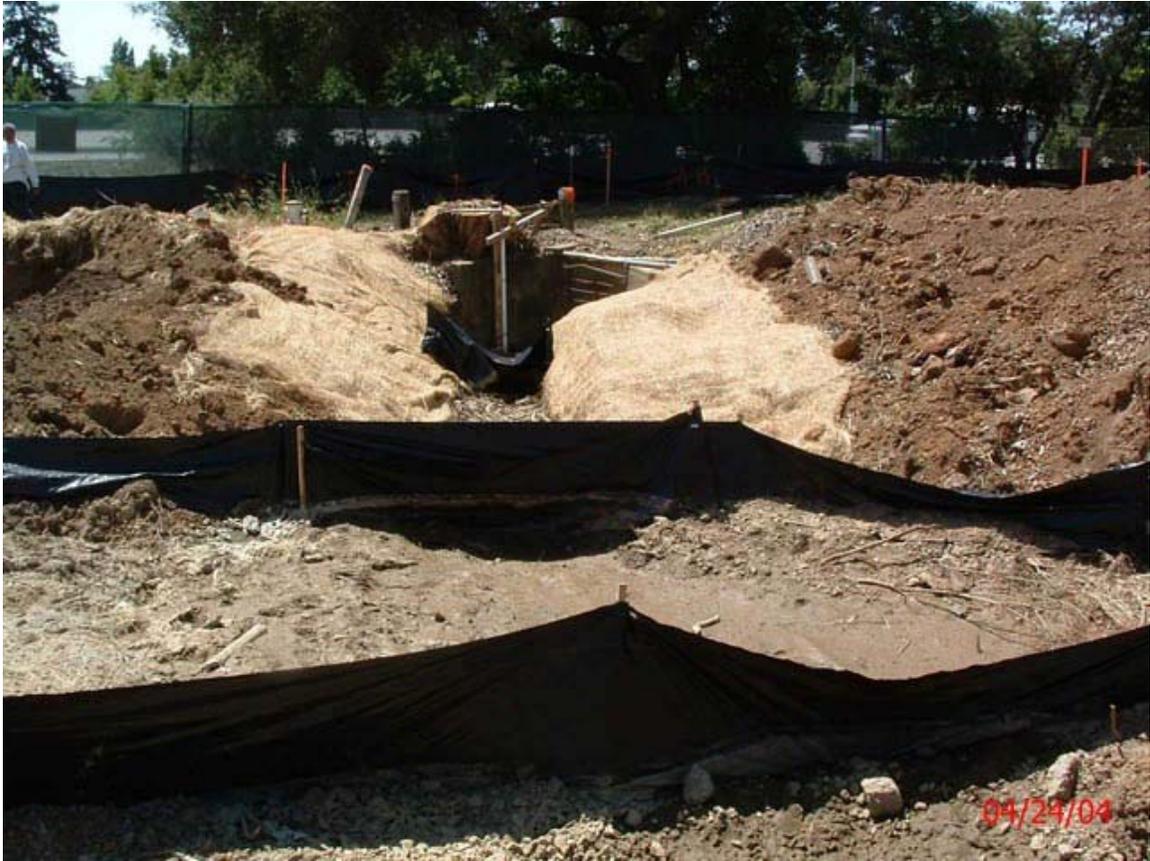
Exhibit 3.3

Photograph by Chiye Azuma on April 24, 2004 of the siltation fences used as a mud barrier at the Leona Quarry construction site. A drain inlet connecting directly to the City storm drains is at the center of this photograph.

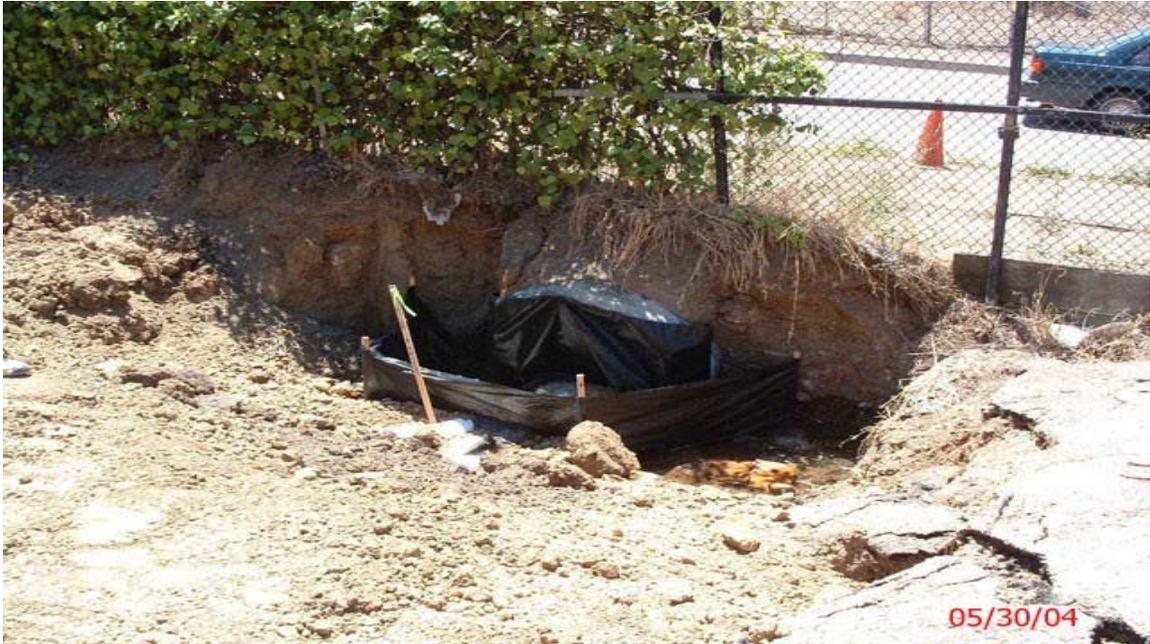
Exhibit 3.4

Photograph by Chiye Azuma on May 30, 2004 of filter fabric wrapped around a storm drain inlet at the Leona Quarry construction site. The roadway on the other side of the fence is Mountain Blvd.

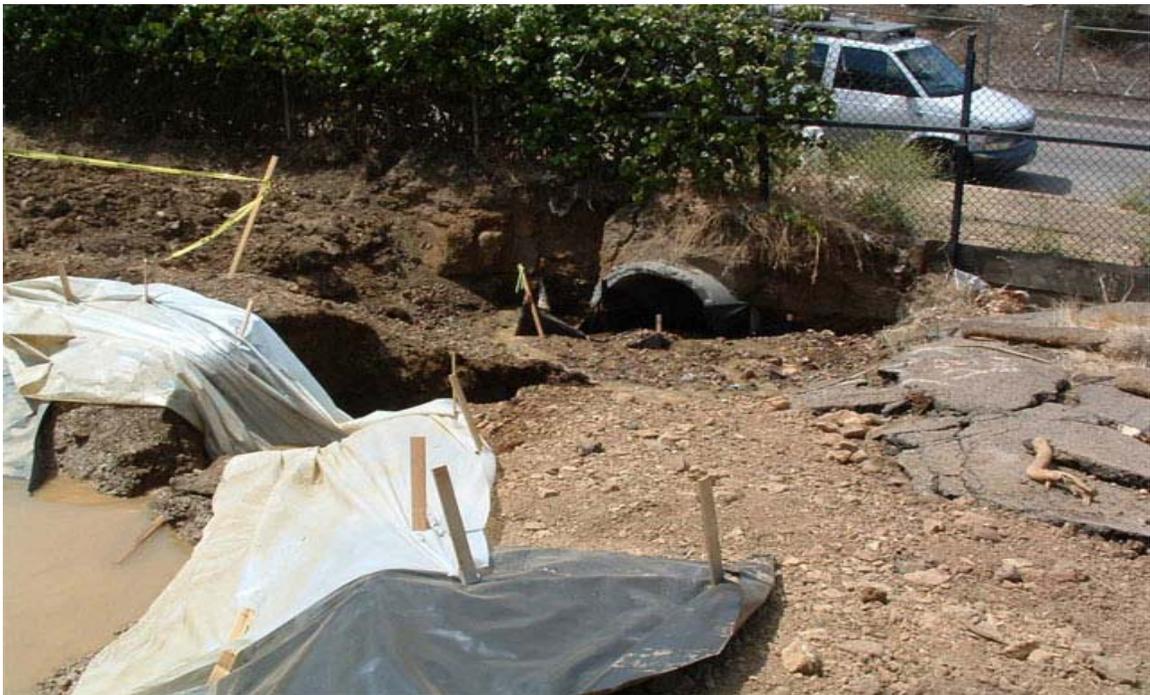
Photograph by Chiye Azuma on July 10, 2004 of sediment pond and mud piled halfway up the drain inlet at the Leona Quarry construction site. The roadway on the other side of the fence is Mountain Blvd.

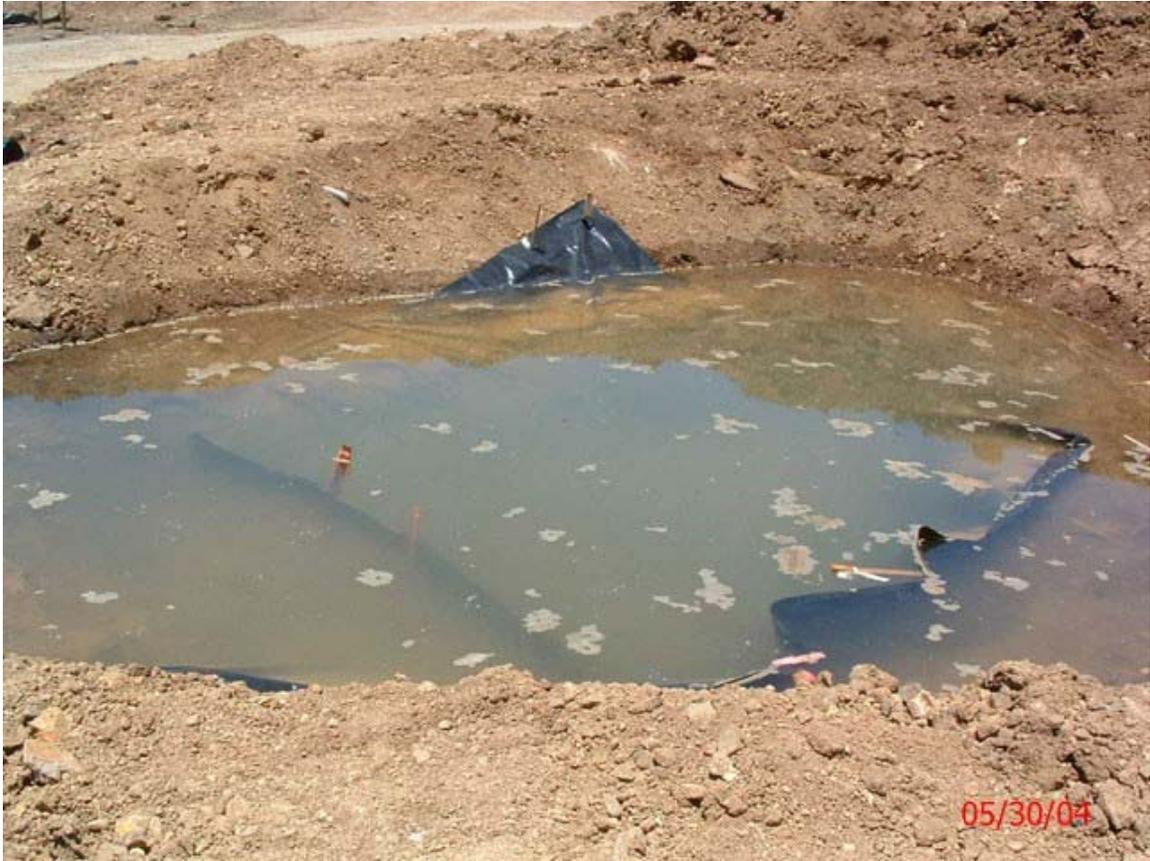
Exhibit 3.5

Photograph by Chiye Azuma on May 30, 2004 of a new siltation pond constructed at the Leona Quarry site next to the Mountain Blvd. drain inlet. The plastic liner for the pond has already peeled away and the ponding water resembles the dirty water observed by downstream residents in Chimes Creek (*See Exhibit 3.2*).

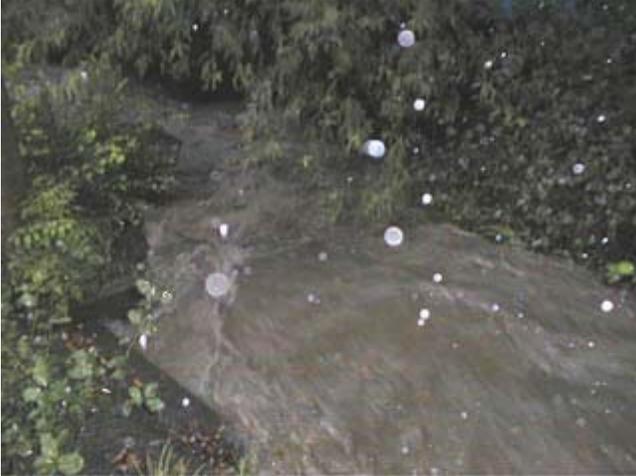
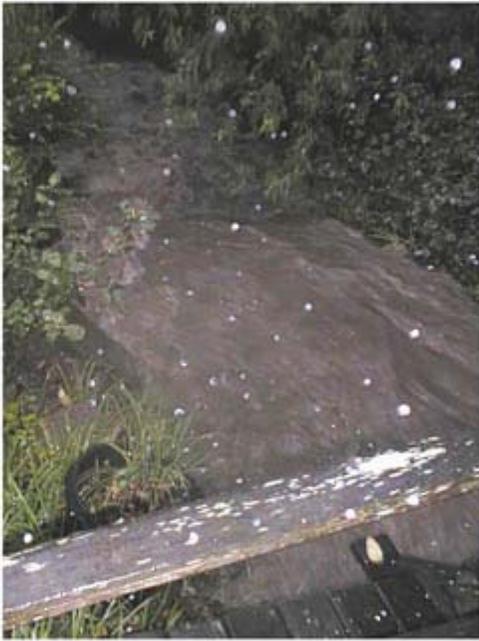
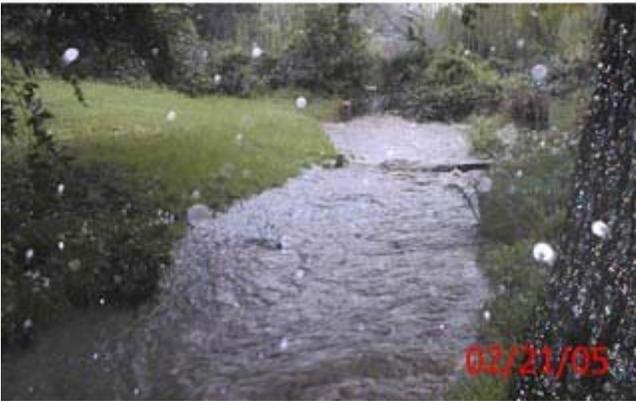
Exhibit 3.7

Photographs by Mark Brest van Kempen on February 21, 2005 of Chimes Creek at 3835 and 3839 Delmont Ave.

38. On February 21, 2005, Chimes Creek experienced flash flood-like conditions. The creek water rose rapidly and high, taking down the hanging sewer main at 6311 Hillmont and lifting the manhole cover and spewing sewage for hours at 6120 Oakdale. And yet, according to Mr. Brest van Kempen, the detention pond did not fill up as it would even in a fairly mild storm. It would appear that the temporary weirs were removed as the turbid water was flowing freely through the openings in the detention pond. Due to the Presidents’ Day holiday, DeSilva staff was not present at the project site. There was no one onsite to monitor the flow or turbidity or pumping, or the damaging flows to Chimes Creek. *See* Exhibit 3.7.

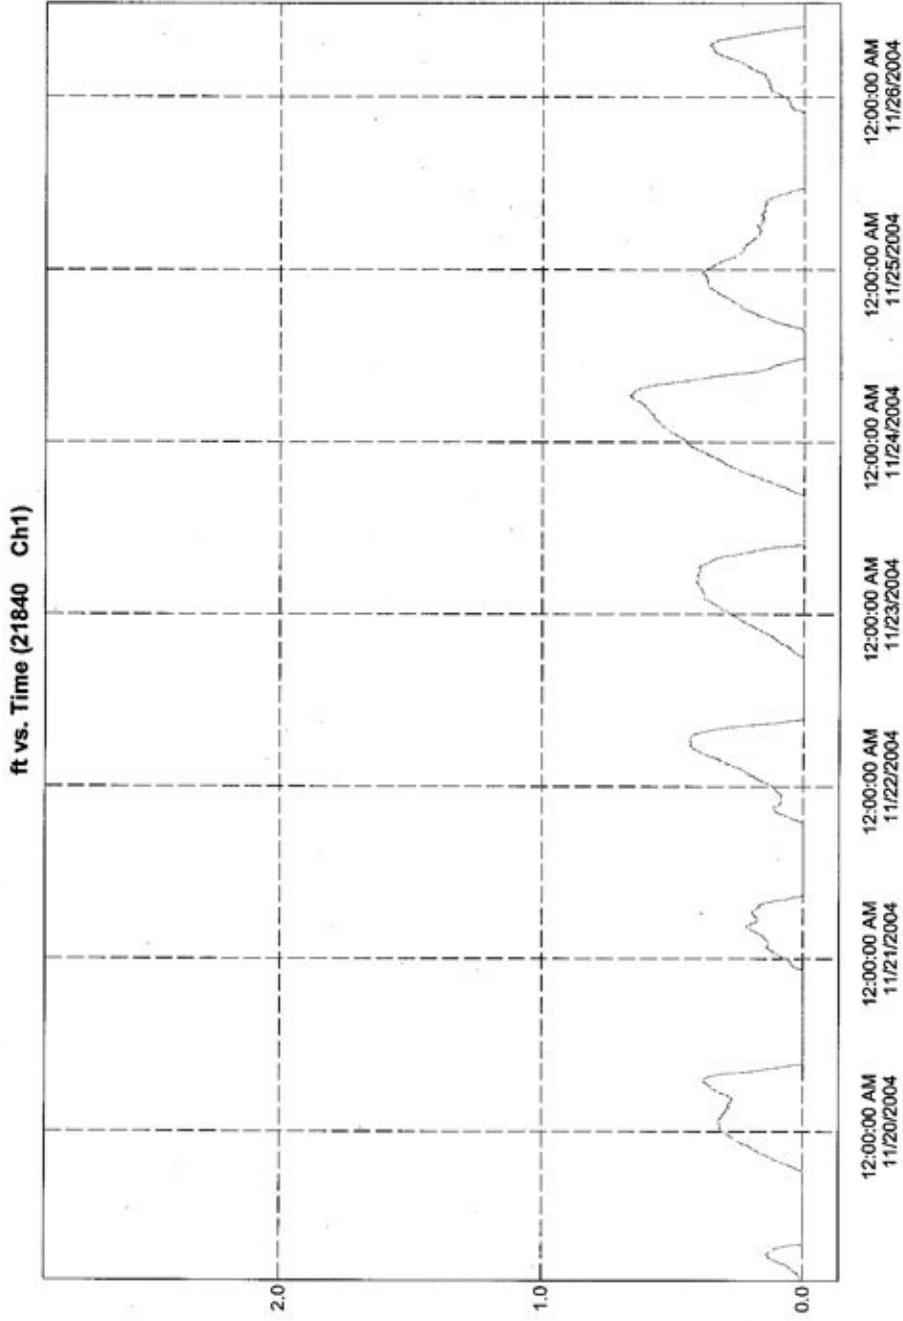
Exhibit 3.8

J-1. FLOWGAGE DATA
11/20/04 - 11/26/04

http://chimescreek.info/wst_page4.html#ACWD%20data. The County refers to this stretch as Line J-1, known to us more familiarly as Chimes Creek. *See id.* The data covered the period from October 18, 2004 thru February 9, 2005, and recorded the flow in cubic feet per second (cfs) at 5 minute intervals. Mr. Codd had called me earlier in March when he noticed a peculiar anomaly in the flow data readings at Chimes Creek. He had noted at least two distinct periods lasting about two weeks each during which the flow volume would gradually increase starting at around 6 p.m., peaking at around midnight, and then gradually tapering off to a higher-than-normal baseline flow by 7 a.m. The resulting hydrograph has an unnatural oscillating wave pattern; I have never heard of a naturally occurring pattern of storm events that begin and cease on a regular time schedule every night for a period of two weeks. *See* Exhibit 3.8. The first period began on November 18, 2004 and lasted through December 6, 2004. The second cycle was shorter, starting on January 10, 2005 and lasting for about a week.

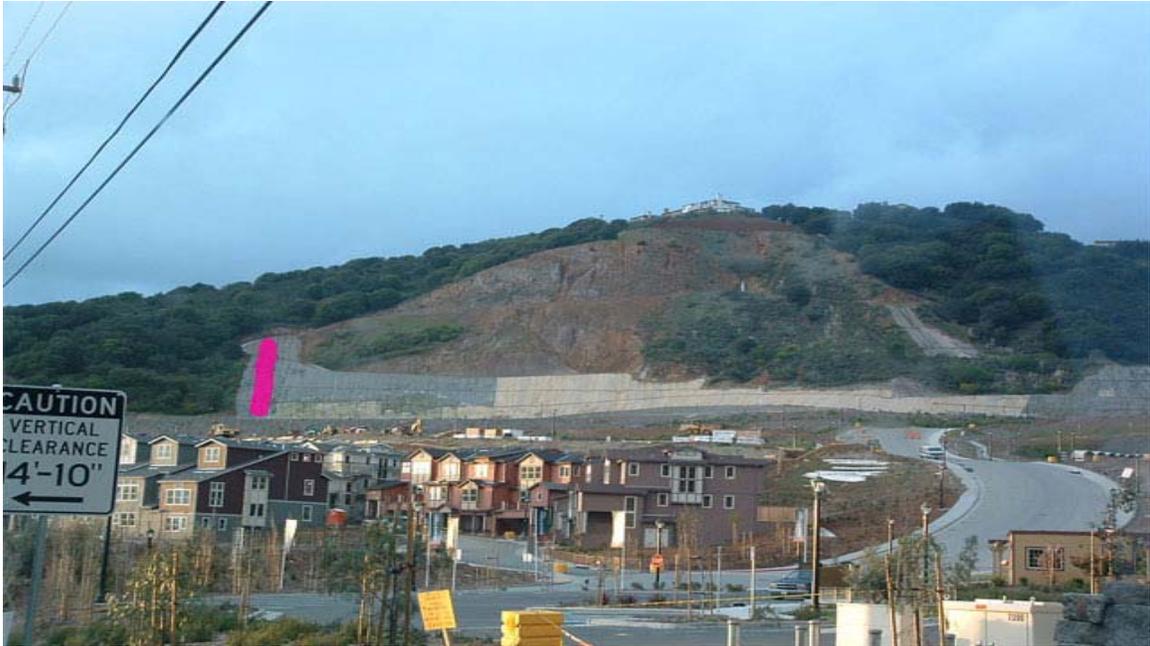
Exhibit 3.9

Photograph by Chiye Azuma on March 10, 2006 of steep slope under the Ridgmont Development. The magenta line represents the pipe that Nancy Sidebotham saw being buried in the slope during the summer of 2005.

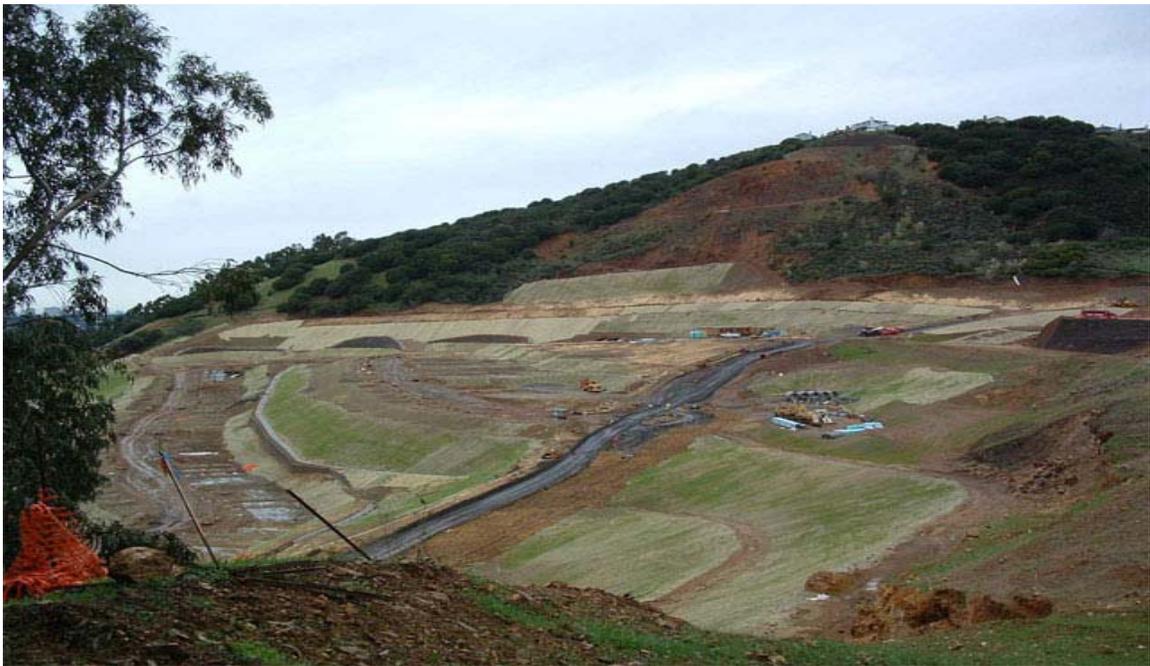
Photograph by Chiye Azuma on January 7, 2005 of the same steep slope under the Ridgmont Development. The Leona Quarry construction site and detention pond is in the foreground.

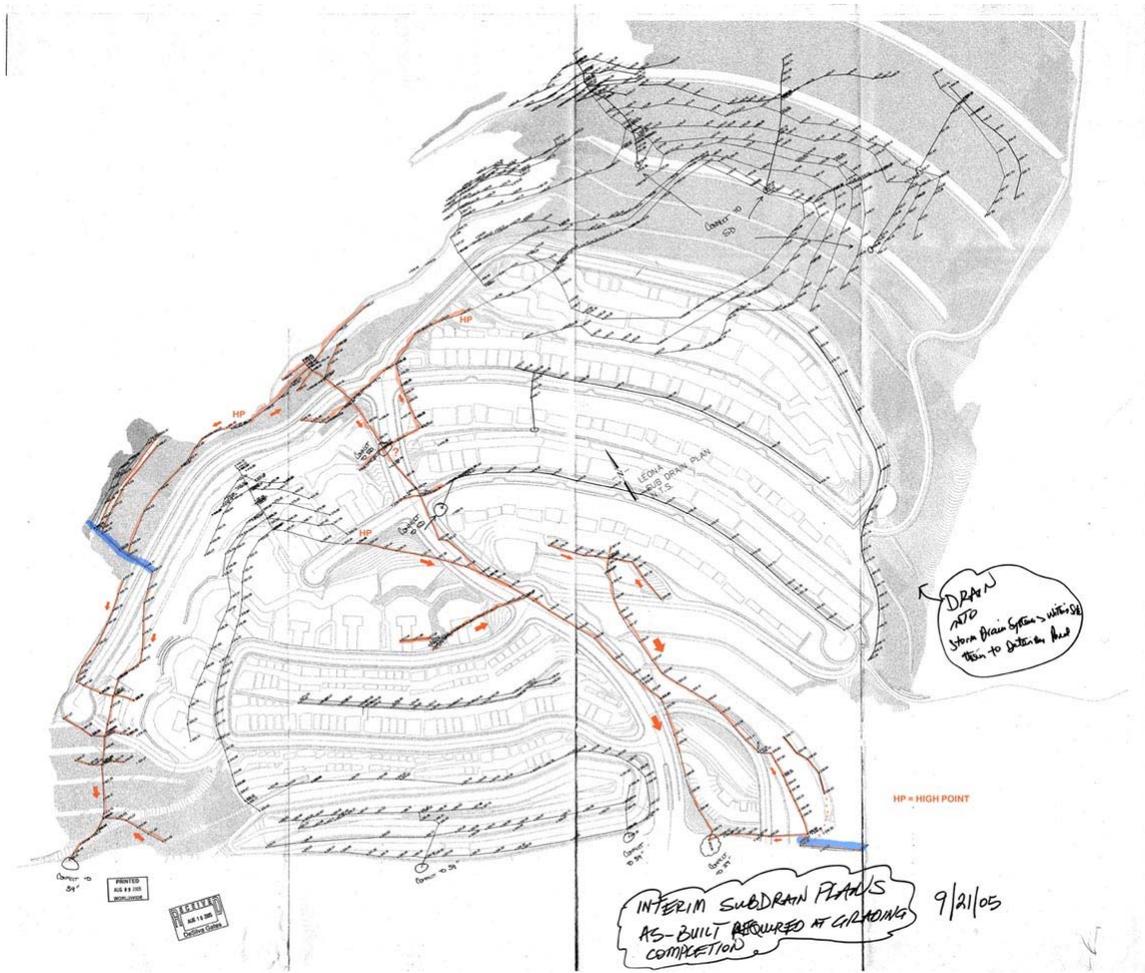
Exhibit 3.10

Interim Subdrain Plans dated September 21, 2005, provided by the City of Oakland to MHA in response to a Public Records Request. Coloring added by Chiye Azuma. The orange lines represent subdrains that appear to drain directly into the City's storm drain system, bypassing the detention pond. The two short blue lines mark the location of the large diameter pipes observed by Nancy Sidebotham (See Ex. 3, ¶ 41).

development.” However, a review of the Interim Subdrain Plans shows that there are at least three additional drain inlets on this project site that drain runoff from subdrains and concrete v-ditches criss-crossing the project site. *See* DeSilva, “Interim Subdrain Plans,” (August 9, 2005). All of these inlets appear to be connected directly to the 39” City storm drain, and not to the detention pond. *See id.* Mr. Lichten of the RWQCB confirmed in his email of March 17, 2005, that the Board is only aware of two 6-inch subdrains that convey storm water directly into the city storm drains without entering the detention basin. There is also the additional runoff from Ridgemont that DeSilva agreed to drain as part of the COA – and it all adds up to a significant burden on the downstream environment. I still cannot determine whether all of these flows were included in the City’s hydrologic modeling of downstream drainage capacity.

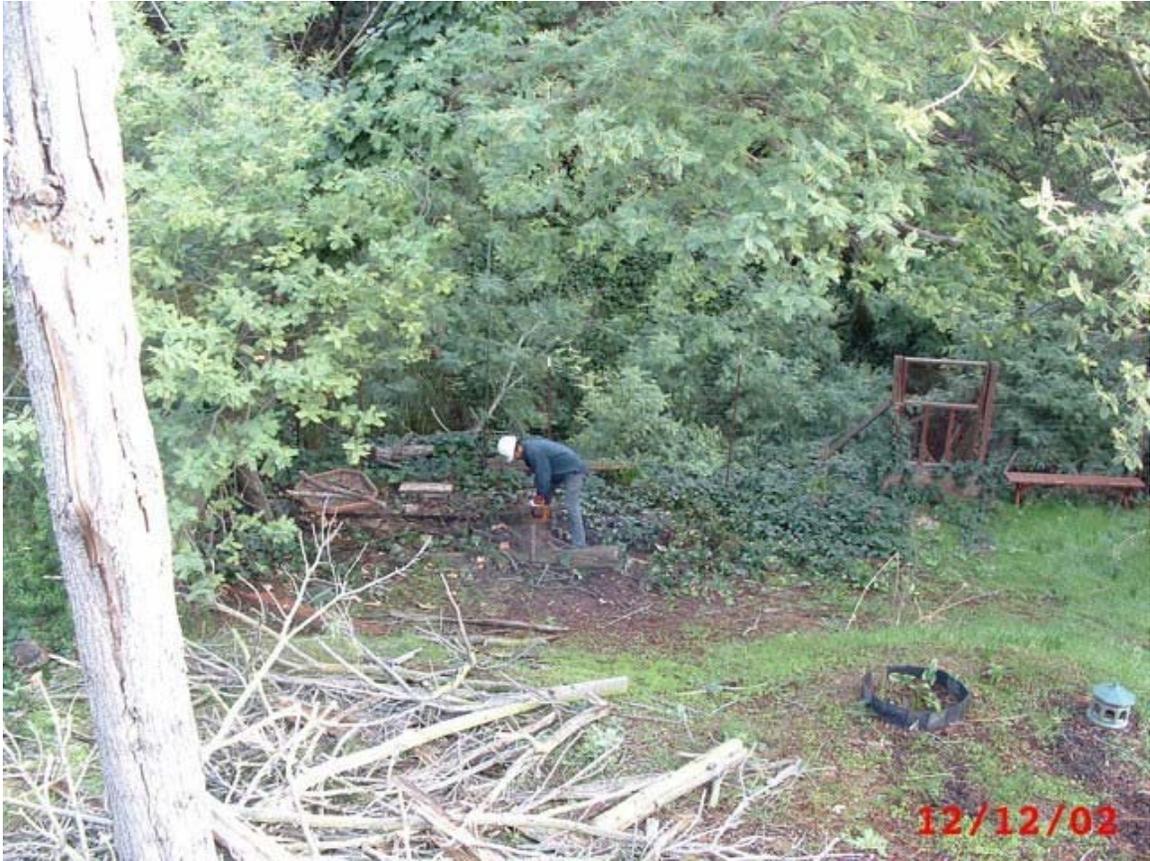
Exhibit 3.11

Photograph by Chiye Azuma on December 12, 2002 of backyard of 3839 Delmont Ave. facing Chimes Creek. Two rainy seasons after construction began at the Quarry, the creek banks have eroded to the extent that the earth supporting the wood gate, wire fencing and redwood benches is lost.

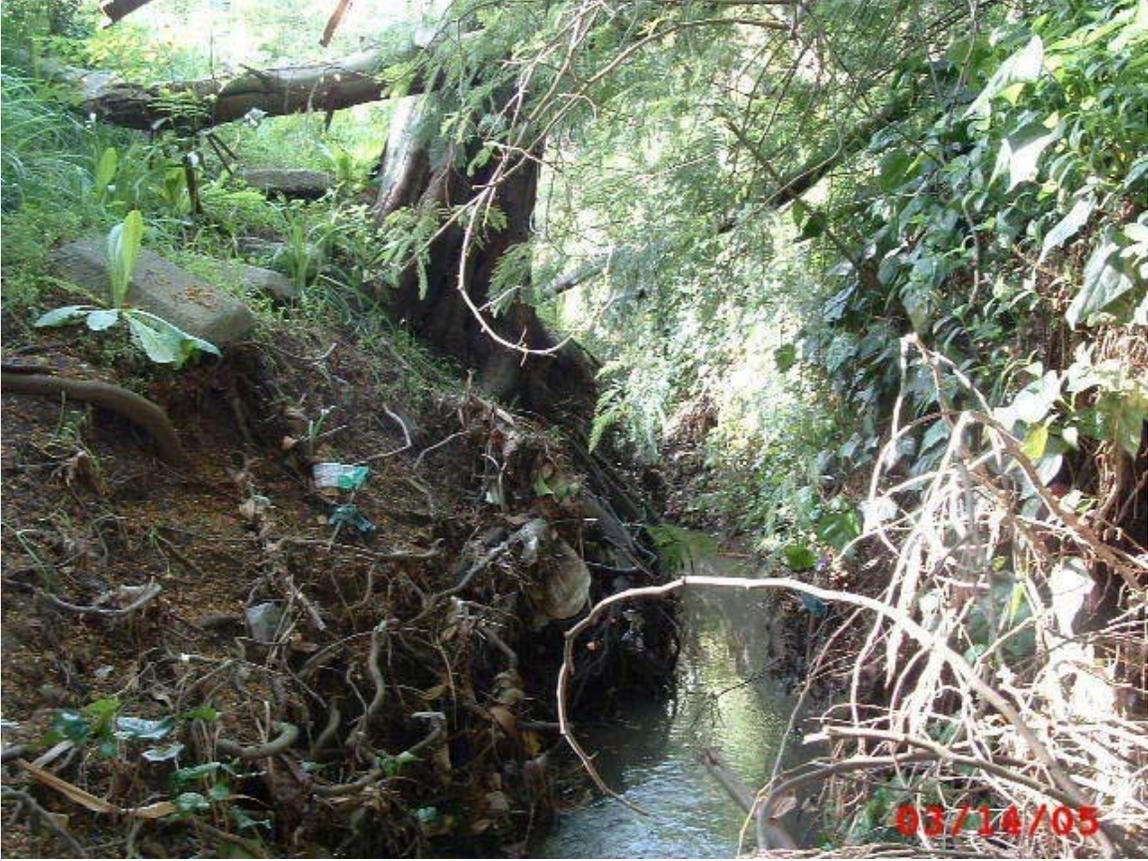
Exhibit 3.13

Photograph by Chiye Azuma on March 14, 2005 of acacia tree along Chimes Creek.

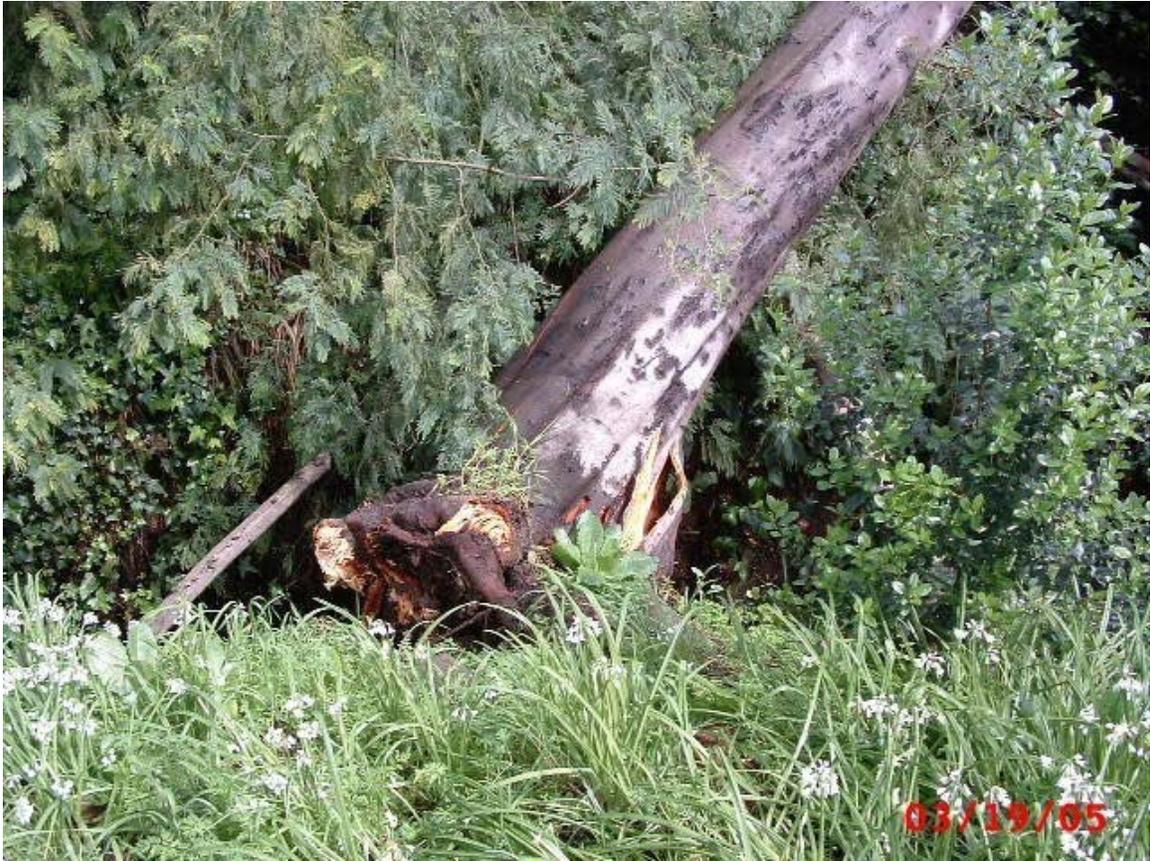
Exhibit 3.14

Photograph by Chiye Azuma on March 19, 2005 of fallen acacia tree facing Chimes Creek.

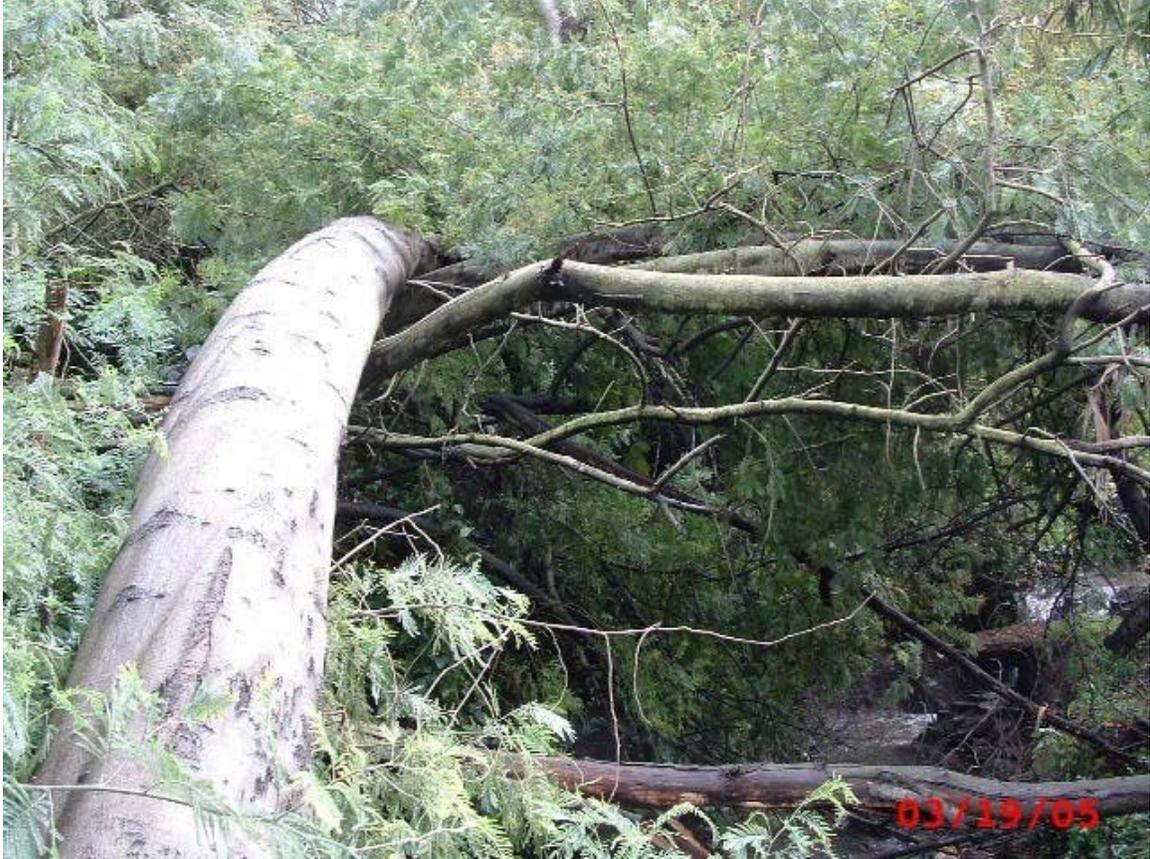
Photograph by Chiye Azuma on March 19, 2005 of acacia tree fallen over Chimes Creek.

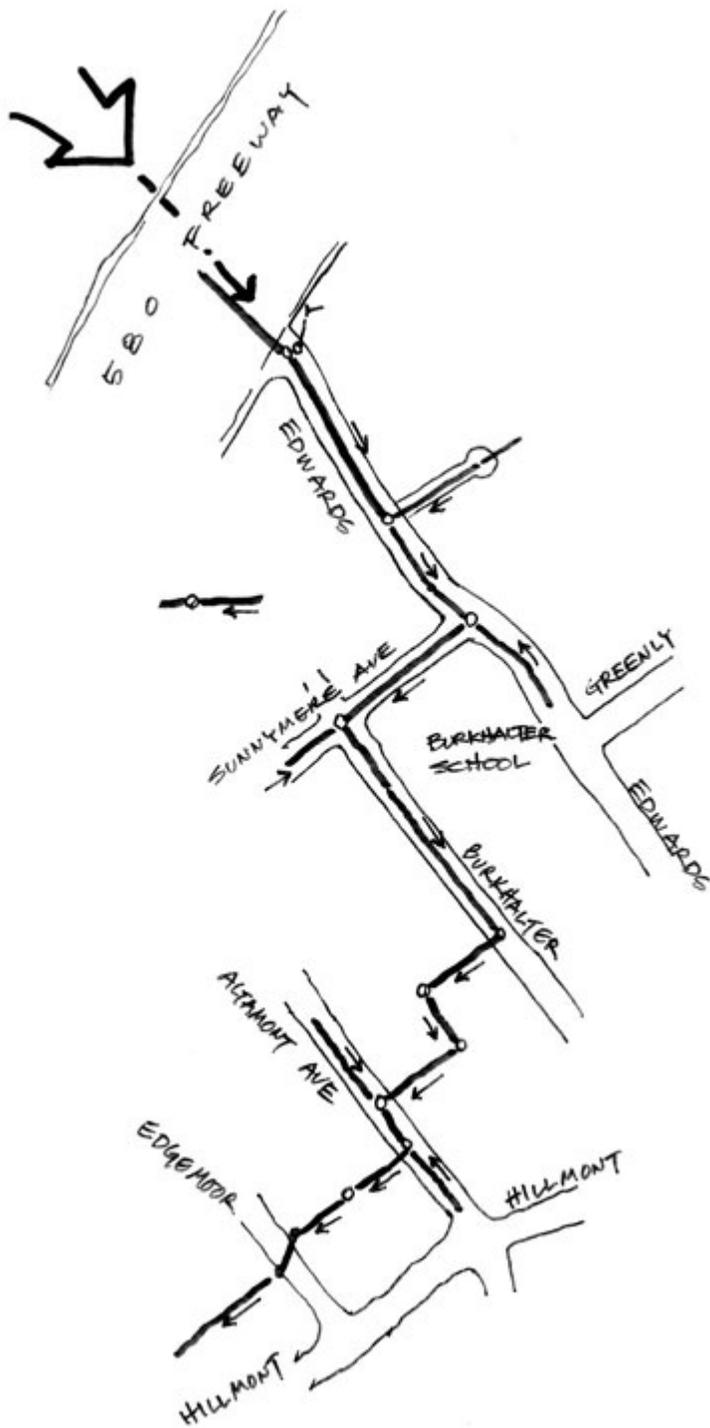
Sanitary Sewer Diagram by Chiye Azuma.

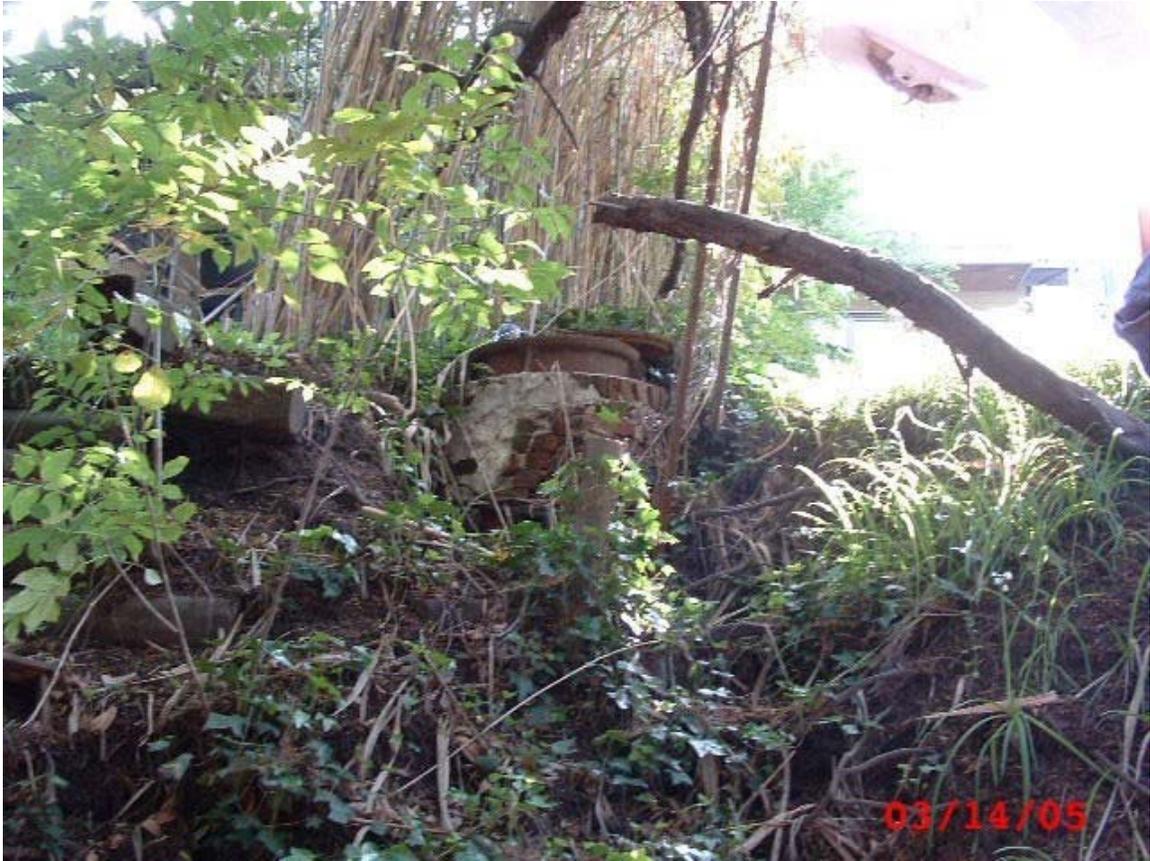
Photograph by Chiye Azuma on March 14, 2005 of the exposed brick manhole along Chimes Creek between 3829 and 3835 Delmont Ave. The concrete mortar patch on the left half of the manhole structure points to past efforts to seal the porous joints.

52. During the creek walk that I undertook with Mr. Brest van Kempen on March 14, 2005, we noted exposed sanitary sewer manholes and pipes along the creek on both sides. *See Exhibit 3.16.* There are a number of areas along the creek where sewer odor can be detected year-round, indicating old and leaky pipes. In between 3829 (my property) and 3835 Delmont Avenue (Mr. Brest van Kempen’s property) is a brick manhole, which is entirely exposed to the creek on one side. *See Exhibit 3.17.* Each time the creek rises beyond a certain level, the porous brick walls appear to allow a free exchange of fluids with the creek. During the warm summer days there is often a pungent odor emanating from this manhole. *See Spreadsheet of Observed Sanitary Sewer Discharges (Exhibit 3.18).*

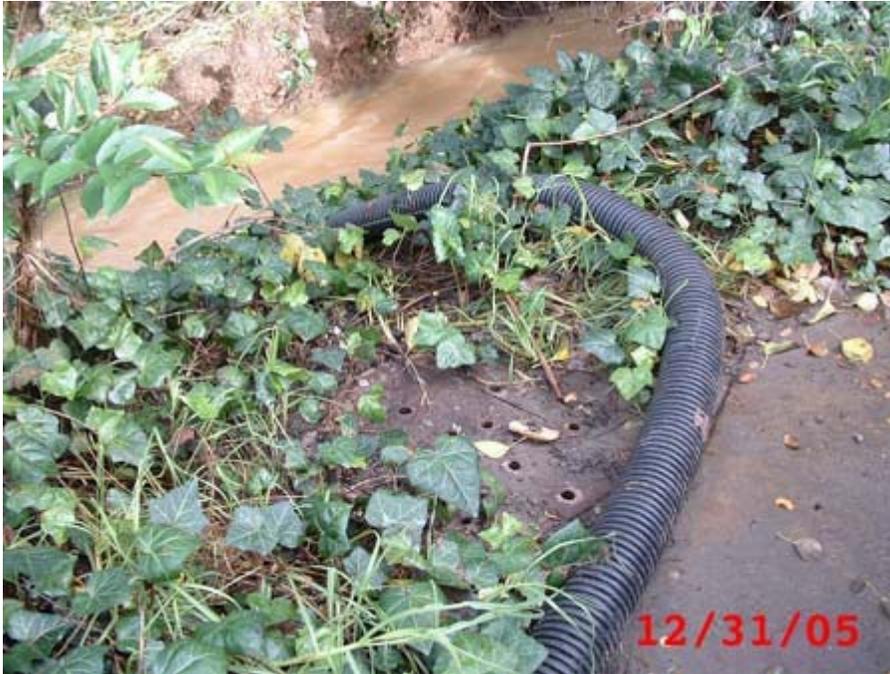
Photograph by Chiye Azuma on December 31, 2005 of manhole #83-400-65 behind 3855/3859 Delmont Ave. During high flow conditions, this manhole is completely submerged by creek waters.

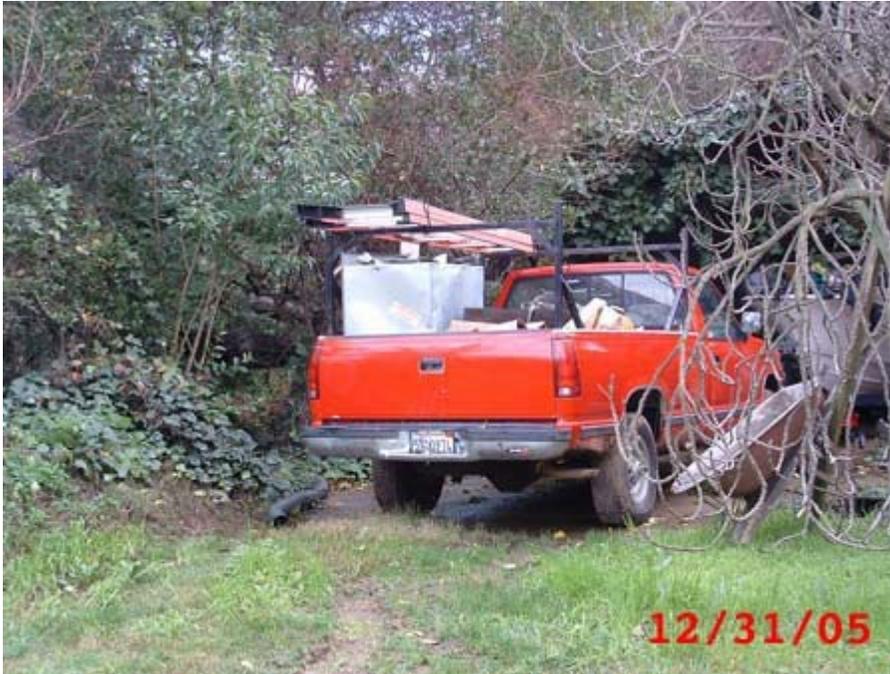
Photograph by Chiye Azuma on December 31, 2005 behind 3855 Delmont Ave. facing Chimes Creek. The sewer manhole is located next to the black pipe on the ground. On December 18, 2005, the creek waters flooded this back yard, rising to the center of the truck's hub cap.

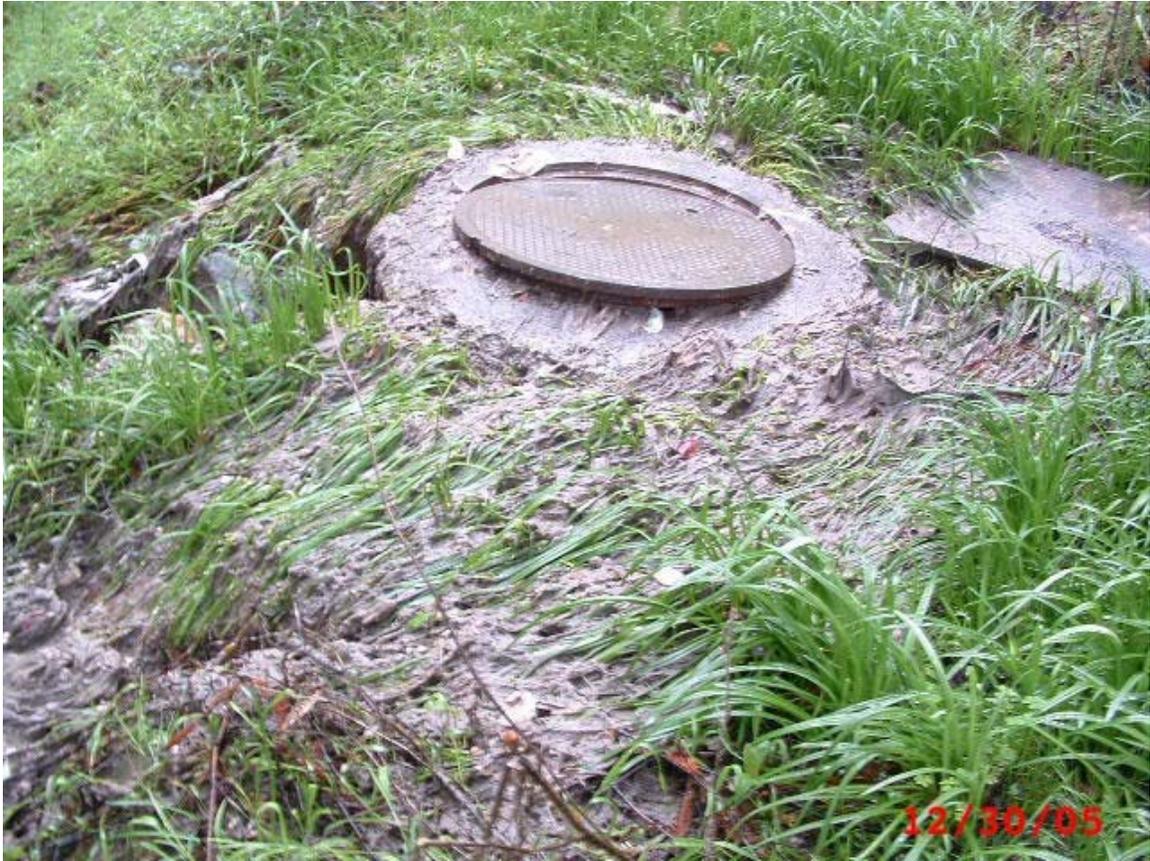
Photograph by Chiye Azuma on December 30, 2005 of the aftermath of a two-day sanitary sewer overflow at 6120 Oakdale Ave. Although a City Maintenance crew was sent out to stop the overflow, no attempt was made to clean up fecal matter trailing down to the Creek or to reseal the dislodged cover.

overflows (SSO) downstream at 6120 Oakdale Avenue (*see* Exhibit 3.21) it also would appear that there is plenty of storm water infiltration from low lying manholes such as this, not to mention the porous exposed manholes at 3829/3835 Delmont discussed above.

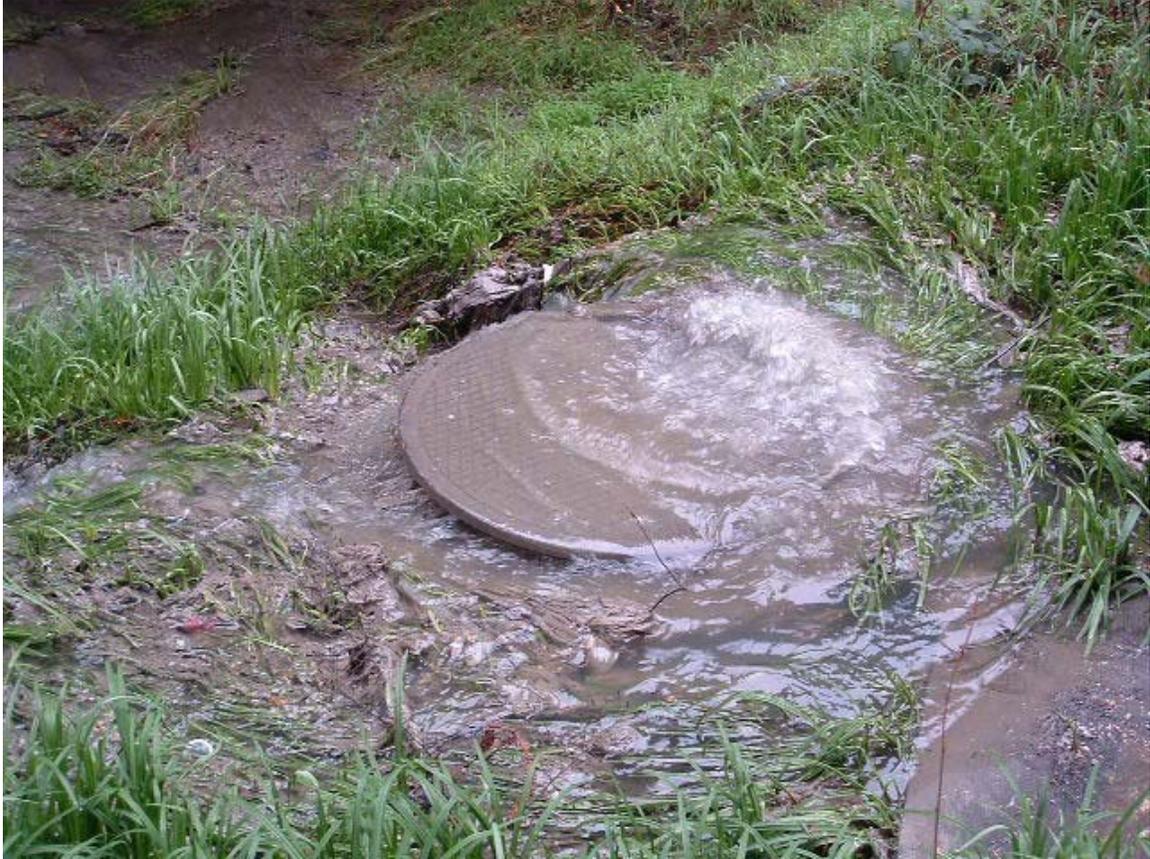
Exhibit 3.22

Photograph by Chiye Azuma on December 29, 2005 of overflowing manhole at 6120 Oakdale Ave. Raw sewage continued to bubble out of this manhole by the Creek even though it had stopped raining two days before.

to repair this and other sanitary sewer problems in time for comprehensive repairs to begin this year. *See Exhibit 3.22.*

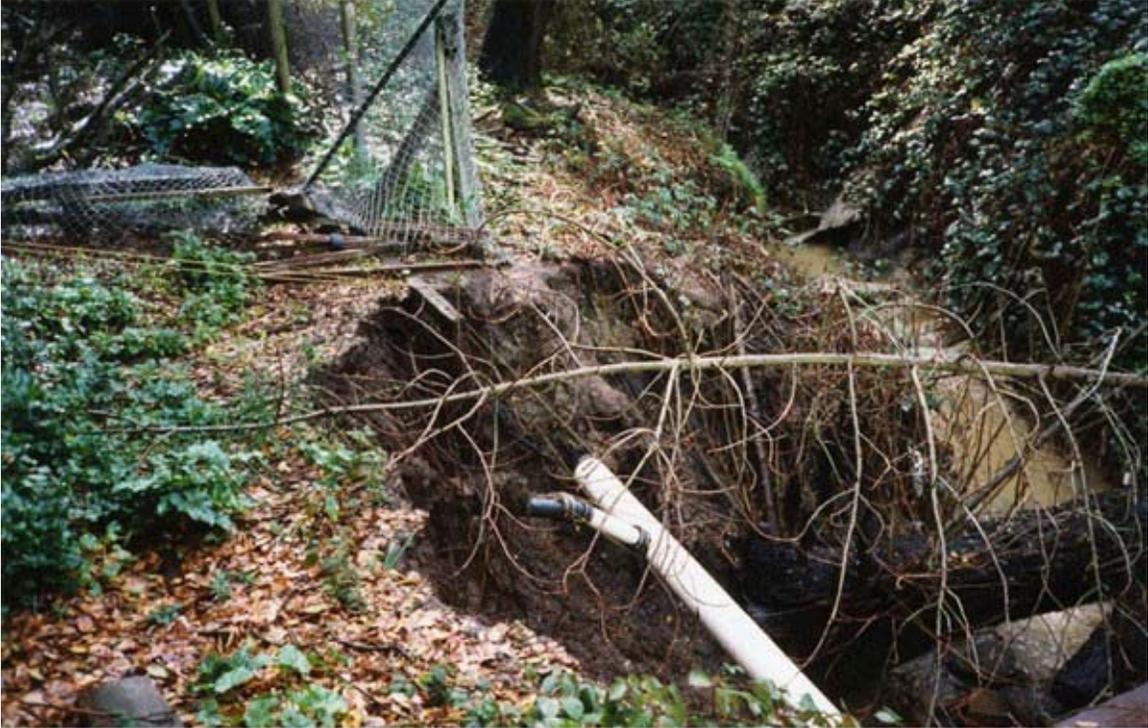
Exhibit 3.23

Photograph by Florence Negherbon in January 1997 of sewer pipe tied to fence and wood plank with rope behind 6301 Hillmont Drive along Chimes Creek.
