Exhibit 3

DECLARATION OF CHIYE AZUMA

*Declaration of Chiye Azuma
Chimes Creek Notice of Citizen Suit*

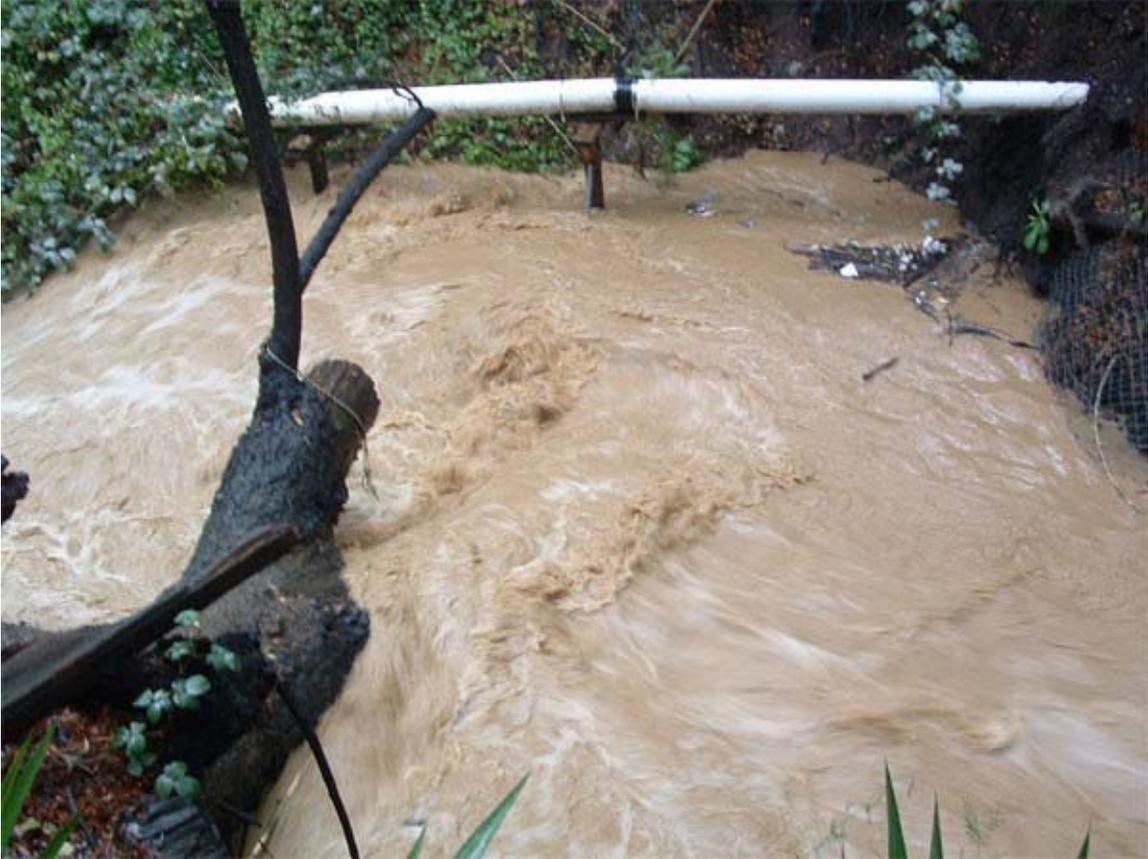
Photograph by Chiye Azuma on December 18, 2005 of walnut tree stump and hanging sewer pipe behind 6301 Hillmont Drive along Chimes Creek.

boulders or any structures to be built in the creek bed. Also, the engineers indicated that the Environmental Services Division had determined that the walnut tree stump should not be disturbed and remain near the exposed sewer pipes. *See* Exhibit 3.24. In the past we have observed creek bank gouging where eddies have formed from tree branches and other obstructions in the creek. It is not clear if or how the city engineers intend to stabilize the north bank (Line N) and prevent such gouging or accelerated “cave ins.”
